TARGET RESPONSE TO EXPLOSIVE BLAST

Final Report

Falcon Research and Development Company
Denver, Colorado

Contract No. DAHC04-69-C-0095

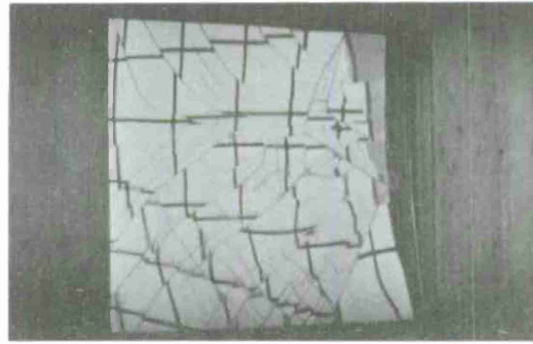
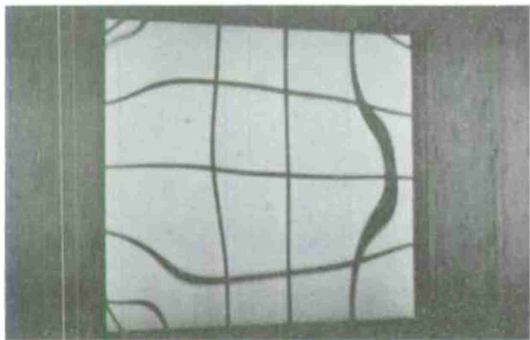
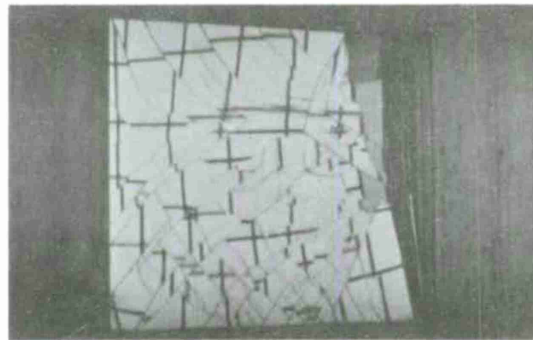
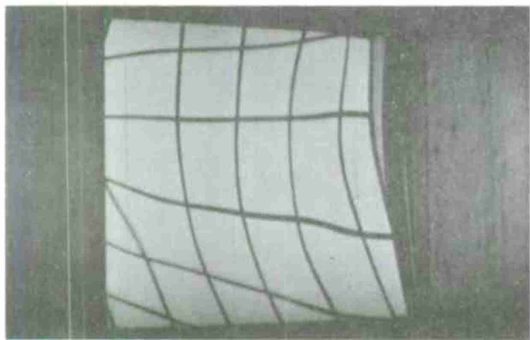
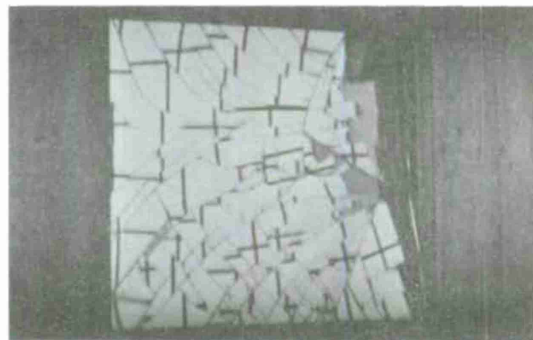
Figure 11. Selected Frames from the Film Record of Window Breakage Taken at 1,000 Frames/Second.

All cameras operated properly on this test and good quality 16-mm photographs of the loading and breakage process were secured. Figures 11 and 12 show series of frames taken from the two film records of the 530-foot window test. These photographs were taken at 1000 and 400 frames per second for Figures 11 and 12 respectively. An analysis of the film records shows that the first cracking of the window took place 35 milliseconds after shock arrival and that the breaking process continued for an additional 10 milliseconds.

The deflection of this window was somewhat more complex than a simple oscillation prior to breakage. The center portion of the window appears to complete a full cycle at about 12 milliseconds after shock arrival; however, the surrounding glass has, at times, moved in different directions than the center of the window. At about +23 milliseconds the left side of the window appears to be well forward of its original position and starting to move in a rearward direction while the right side of the window is beginning to move back from the original position. The total deflection at this point in time is sufficient to allow the right side of the window to escape from the supporting moulding. This would have required a radial deflection of about 3 inches if simple window curvature were assumed. The window continues to be held at the top, bottom and left edges even after the right side escapes from its support. It is interesting that breakage did not occur until twelve more milliseconds elapsed and substantially more window motion had taken place. At breakage, or at least soon thereafter the left side of the window can be seen to be moving forward while the right side is moving backward or into the building.

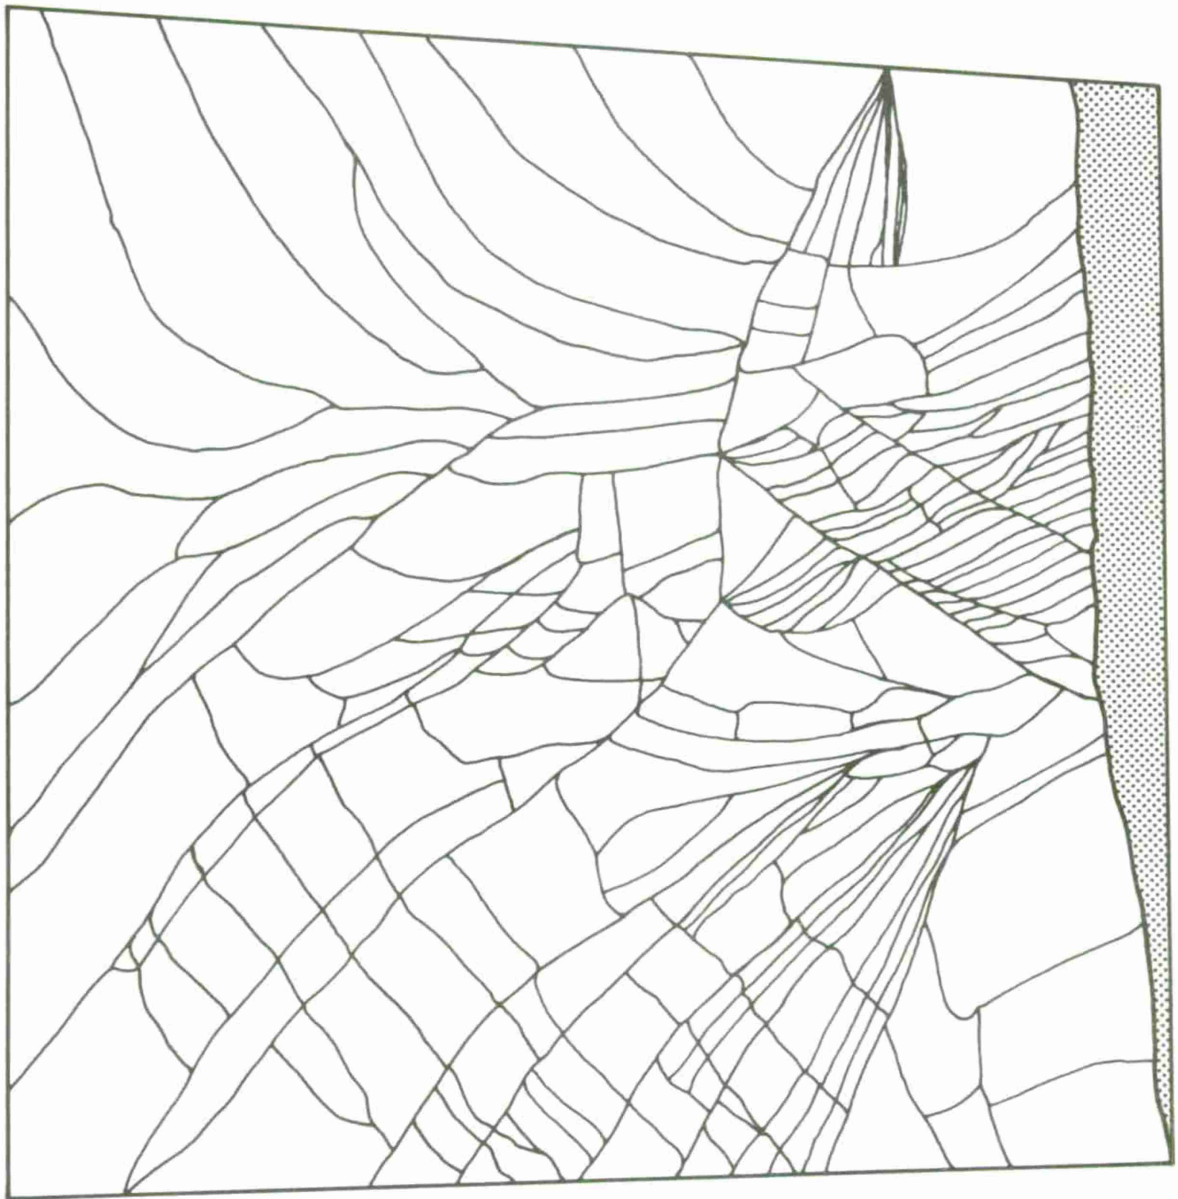
Figure 13. Fragments Produced by the Blast Loading of 4 Ft. by 6 Ft. Plate Glass Window.

in this test of blast interaction with the window. Figure 13 provides a diagram of these fragments. At least for the larger fragments the shape and size of the fragments is clear and can be accurately drawn. The smaller fragments cannot be defined with as much accuracy since they cannot be seen as clearly and since each crack did not always produce a separate fragment. A number of fragments were found on the ground which had cracks within them but which had not been sufficiently fractured to separate. Figure 13 thus represents a best estimate of the discrete fragments into which the window was broken.

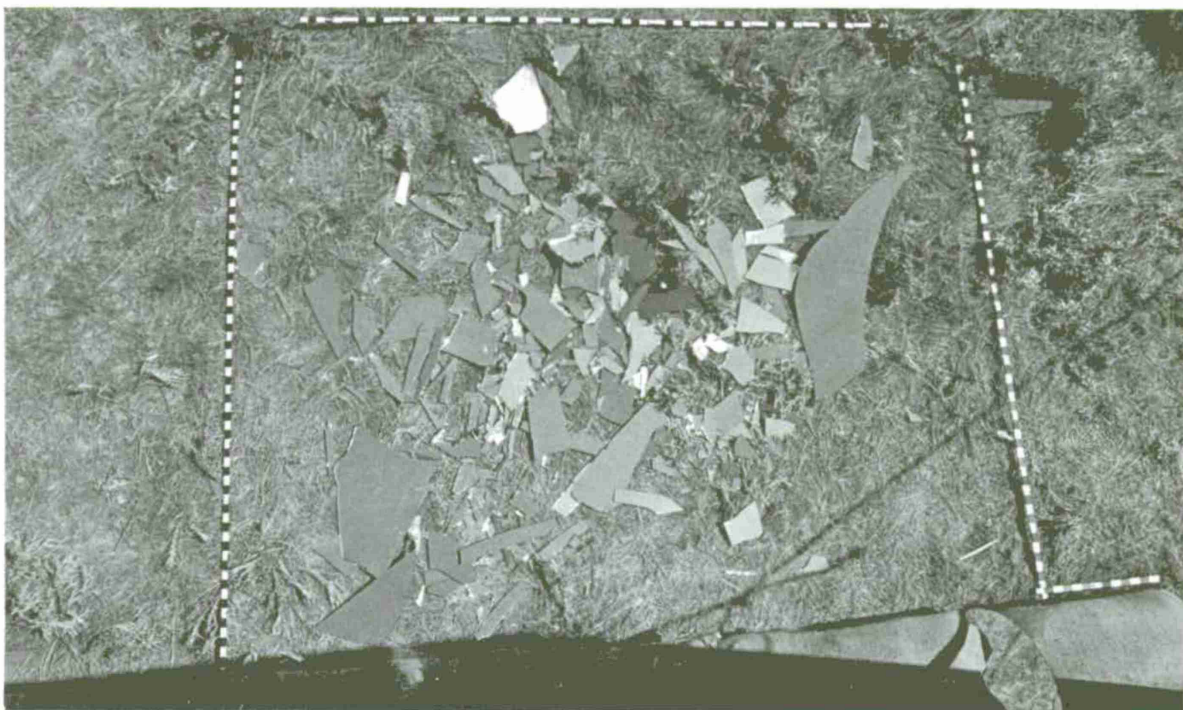
Figure 14. Glass Fragment Distribution Outside the Structure.

The larger fragments which were found on the ground following the test were also examined. Figure 14 shows the pile of fragments which landed outside the building and Figure 15 shows the fragments which went into the building. Very few fragments moved more than six feet forward of the building as they fell outside. Inside the building most fragments were within three feet of the front wall and none reached the back wall, only eight feet away. Approximately 60 percent of the fragment weight fell outside the building and 35 percent inside with 5 percent remaining in or on the window frame.

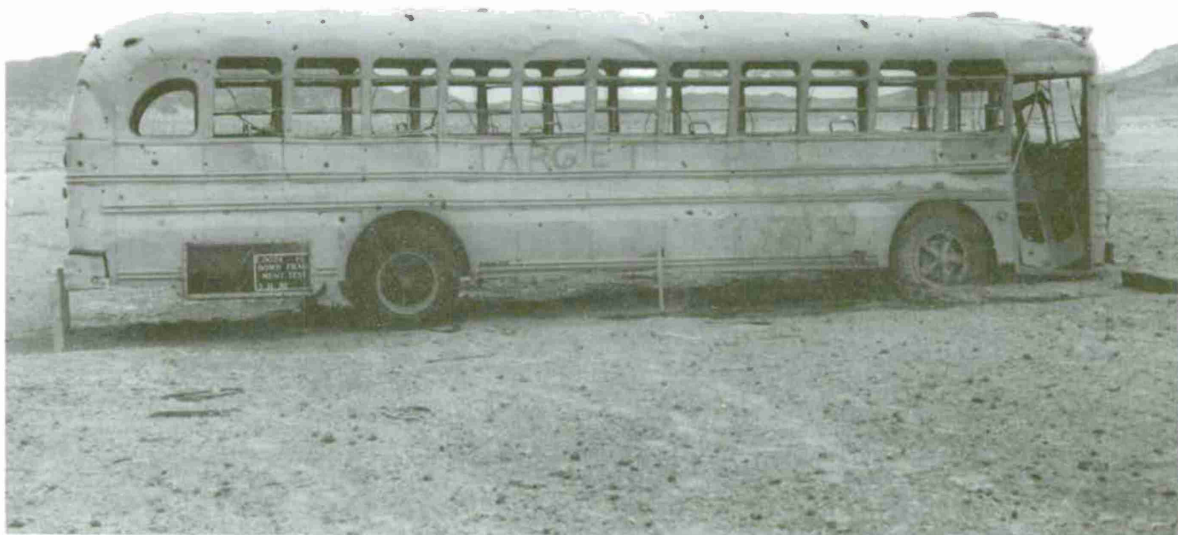
Figure 17. Damaged Bus Following the Test at China Lake.

Other damage to the vehicles which is directly attributable to the blast includes glass breakage, sheet metal deformation, wall rib or stiffener bending, and seat movement.

The sheet metal of the bus was steel, about 0.030 inch thick. Surface bending of this steel is evident in Figure 17. The sheet metal of the truck was heavier, except for the homemade cab, and was damaged less extensively. Maximum deformation of the bus sidewall was 7 to 8 inches on the near side. The far side of the bus was bulged outward only slightly between the vertical stiffeners. The sheet metal below the floor line was bent outward as much as 3 to 4 inches in some locations on the far side of the bus. The bus door was torn loose at the hinge attachment.

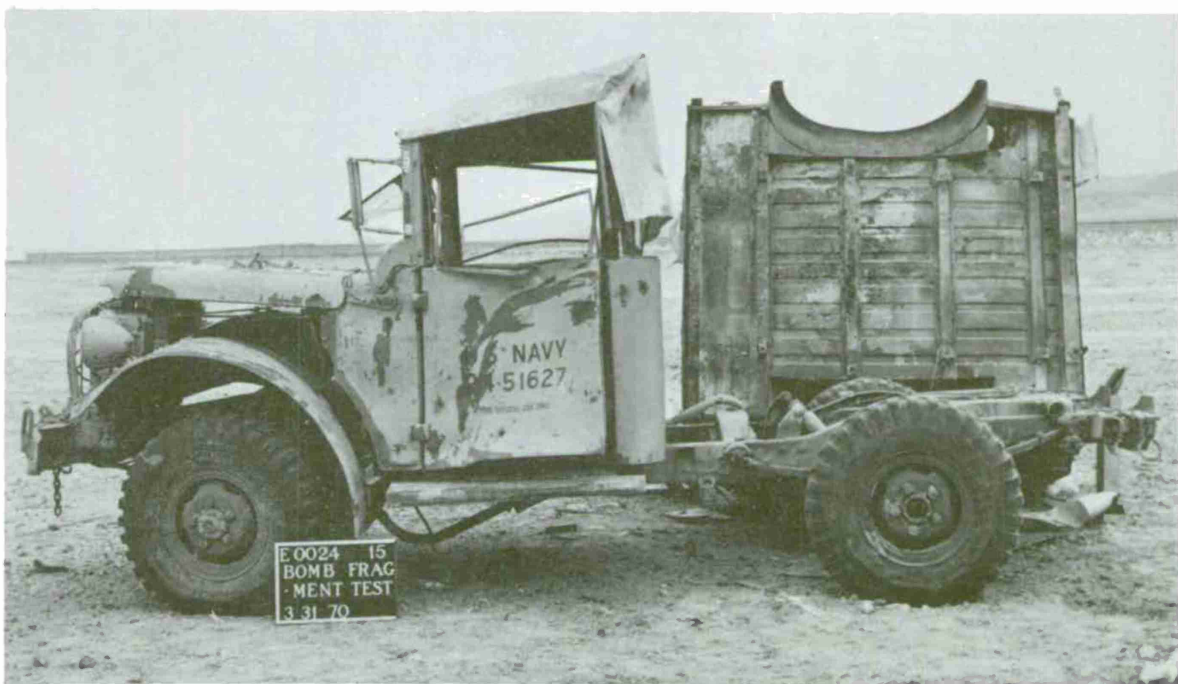
Figure 18. Damaged Pickup-Camper Following the Test at China Lake.

Post test examination indicated that the truck bed had not been securely bolted to the truck frame. An analysis of the potential for overturning the camper body as a separate unit indicates that the observed action would have been predicted. The weight of this unit has been estimated at 700 pounds with a center of gravity 17.3 inches above the frame members and 30 inches laterally from the overturning axis. The computed net impulse required to overturn such a unit is 50 psi-ms, while the actual impulse, from this test at 180 feet, on the camper body was approximately 150 psi-ms. The observed overturning action for this unit would have been much more severe had it not been for the binding, bending, and general restraint provided by the attachment bolts even though they were without nuts. A number of these bolts were seriously bent following the test. Other factors tending to reduce the overturning action for the camper included a 5- to 10-knot wind and poor blast coupling due to deformation and destruction of the near side of the camper by the blast wave.

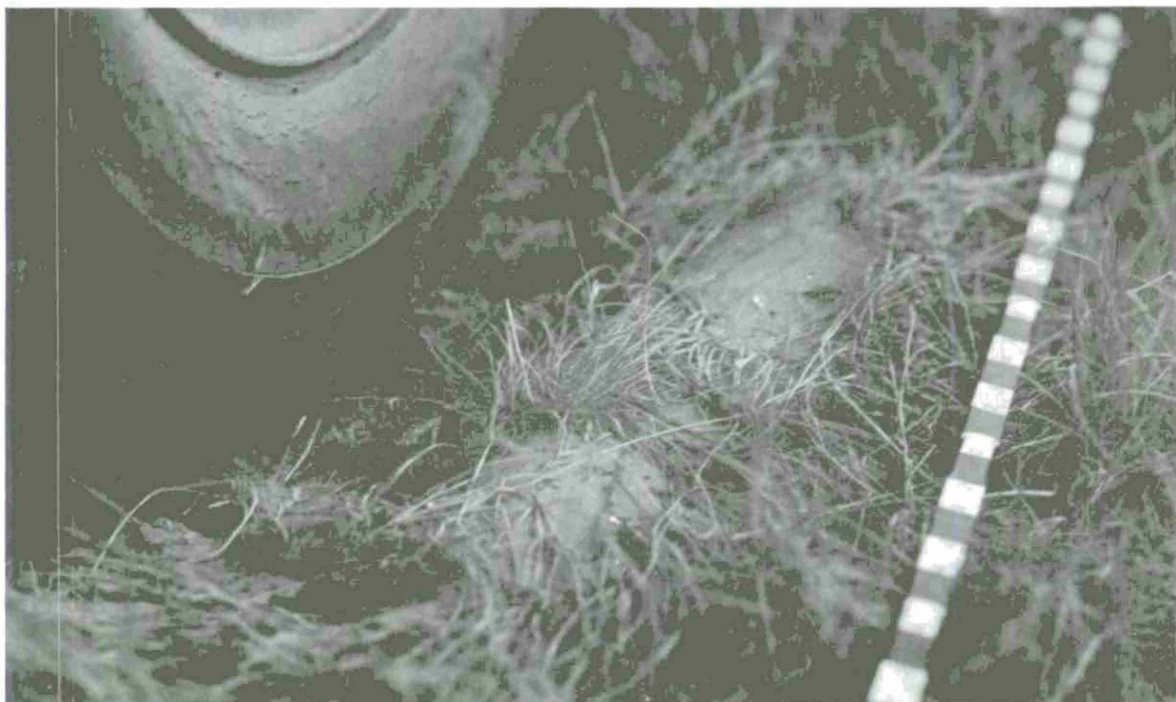
Figure 20. Tire Print in the Soil Following Bus Rotation.

An examination of the earth surface in the vicinity of the tires showed that the tires which were on the far side of the blast had slid along the surface and had dug into the soil at the far edge to a significant extent. Tires on the near side of the vehicle left no marks at all and may have actually been above the surface as the lateral motion took place. This would indicate that the vehicles may have approached an overturning condition but then fell back to their original posi-

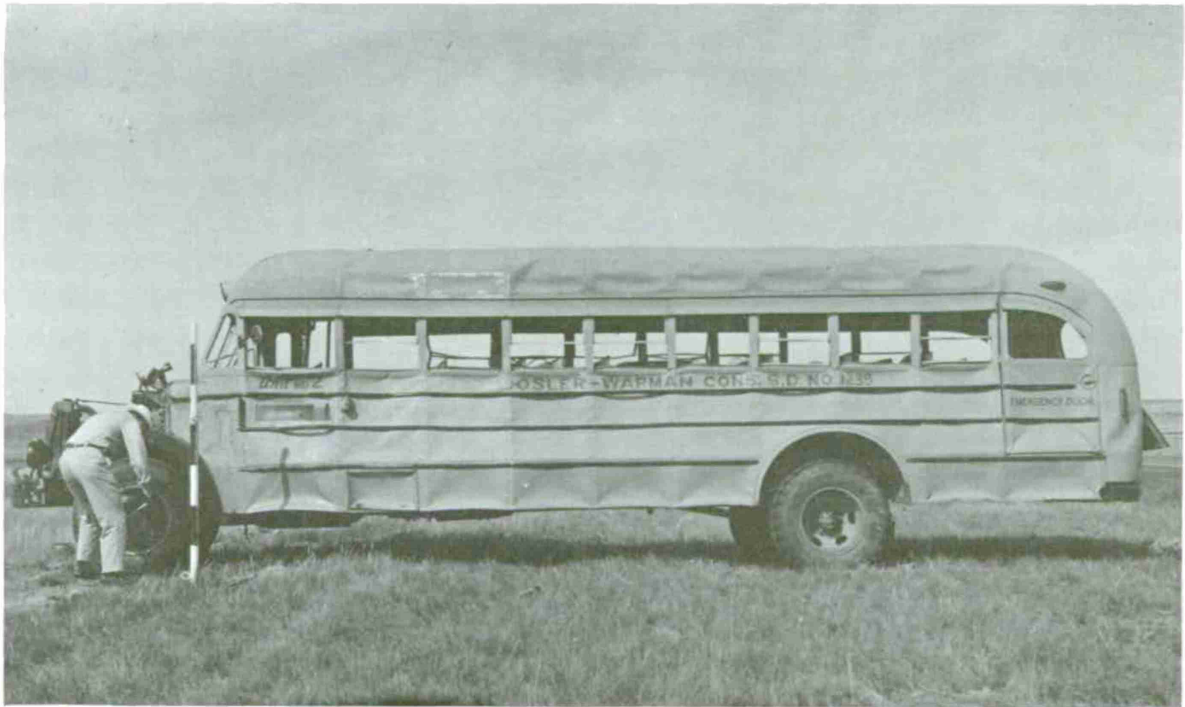
Figure 22. Damage to the Large Bus Following the Dial Pack Test - Side View.

Glass fragments were found forward of the front of the bus; one window was found 90 feet back toward ground zero from the bus; and five or six other windows were on the side toward the blast. There were many windows scattered out behind the bus, and some were found as far as 90 feet downstream from the bus. Some glass fragments were found as far as 115 feet downstream from the bus; however, the main glass and frame debris was within 25 feet of the bus.

The rear wheels of the bus were displaced sideways 11 inches; all windows were broken out of the vehicle except for one small one on the right front by the door which was not even cracked. The three small windows in the door itself were only cracked and not removed. The fourth window in the door was blown out.
